Common Problems and Issues Concerning the Brother HL-1240 (TN-460, DR-400) Engine

DOC-0322

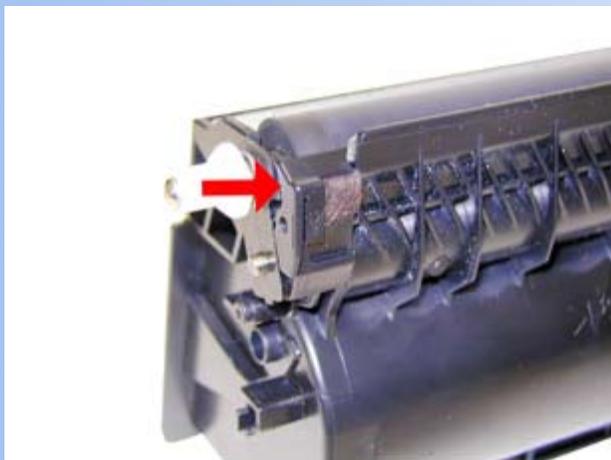
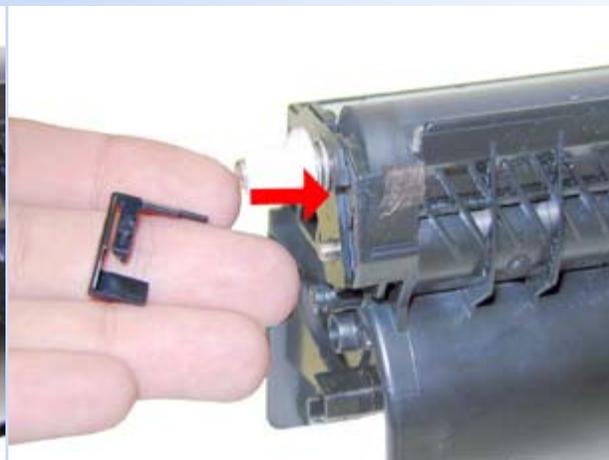
Vertical speckled toner pattern on the right side of the page: Toner Cartridge; This is a common problem. There is a small plastic clip that is on the right side of the developer roller that is held on only by double sided tape. It is very common for it to fall off. In fact we have seen as much as 35% of the cores come in with out these clips. The purpose of the clip is to keep the toner from building up on the edge of the developer roller. If it is missing, the toner will build up, and eventually start to fall off and cause a speckled vertical streak. The left side of the cartridge also has a clip, but it is permanent, and does not fall off. New clips are available. See Figure 2 and 3 for more information. (Figures on next page)
