Panafax UF-585 Toner Cartridges

DOC-0285

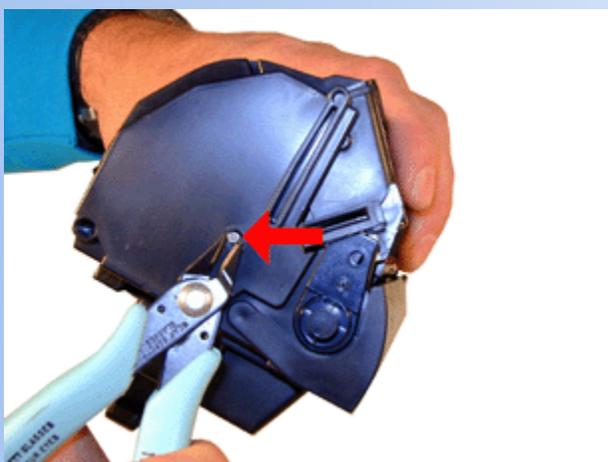
FIGURE 1

1. With the flush cutting wire cutters, remove the two small metal hinge pins. One located on each side of the cartridge, (Similar to an LX cartridge). Flush cutting wire cutters have blades that meet flat at the edge. Normal cutters bend in at the edge making it hard to grab the pins. See Figure 1
2. Take a medium common jewelers screwdriver and pry the inside of the white drum axle away from the side wall of the cartridge. See Figure 2

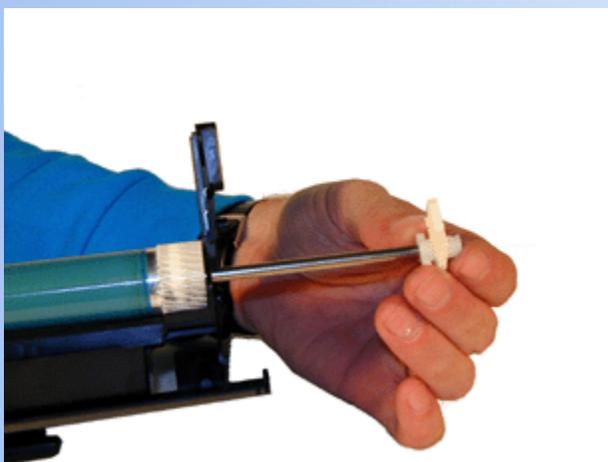
FIGURE 3

3. Pull the white drum axle pin out. A full length axle should come out with it. If not, remove the axle also. See Figure 3
4. Remove the drum, and place aside in a safe dark place.
5. There are 2 screws on the Wiper Blade. Remove them and gently pry the felt seal from both sides of the blade. See Figures 4 & 5.
6. Remove the wiper blade, and clean out any waste toner from the chamber. See Figure 6

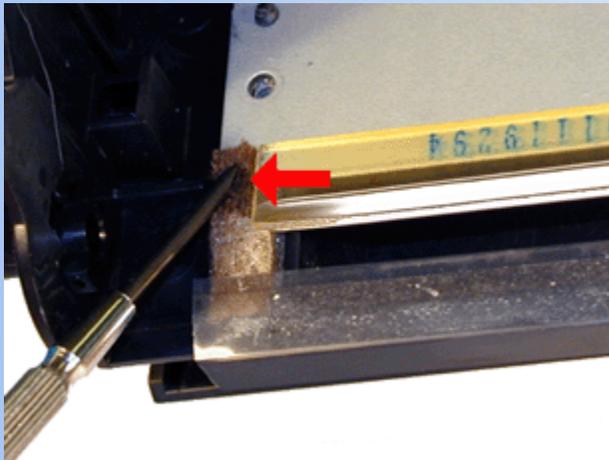
FIGURE 7

7. Install the wiper blade being careful to place the felt seal at the edge of the rubber blade. If the felt seal no longer sticks, use the double sided tape to re-attach it. See Figure 7
8. Coat the drum with Kynar padding powder. Insert the drum axle through the non-gear side and out through the gear. While keeping the end of the axle flush with the drum hub, install the drum into the cartridge. Press the drum axle in so it fits into the black drum axle pin on the non gear side. See Figure 8

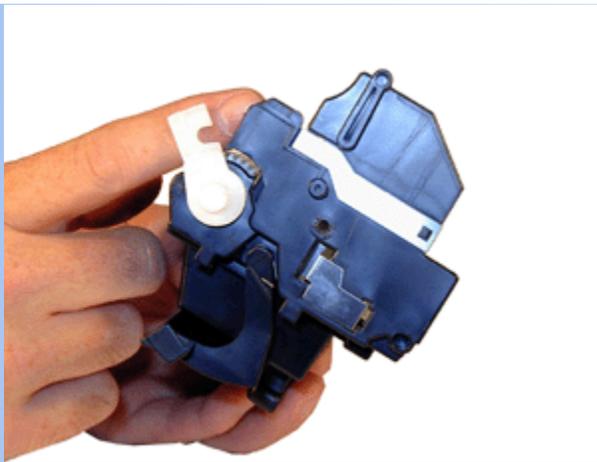
FIGURE 9

9. Install the White drum axle pin, slide back into place. See Figure 9
10. On the supply side, carefully pry the PCR out of it's holder. These PCRs fit very tightly, be careful not to break the holders when removing them. See Figure 10

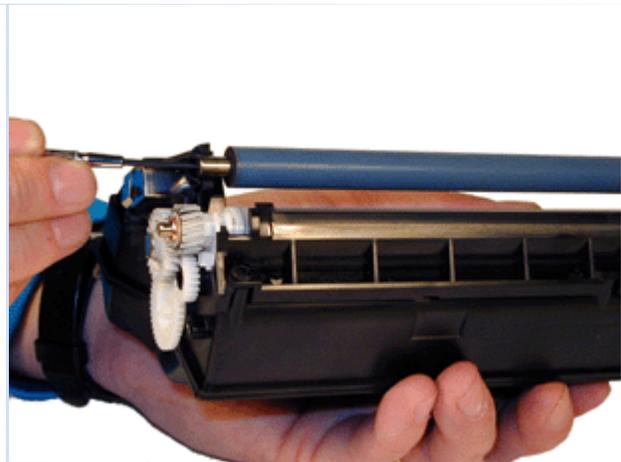
FIGURE 10

WARNING: Do not clean the OEM PCR with alcohol as this will remove the conductive coating on the roller. We recommended it be cleaned with your standard PCR cleaner

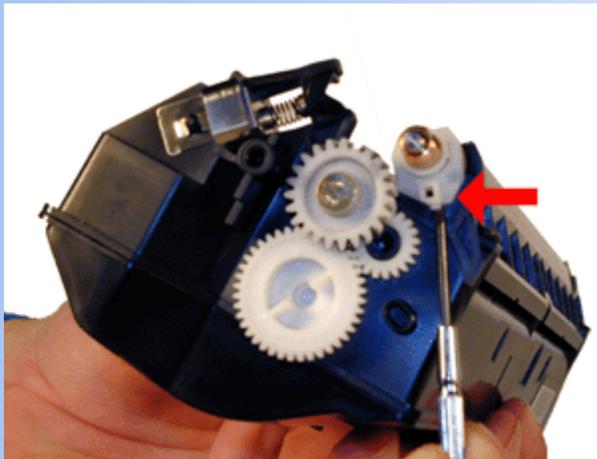
FIGURE 11

11. Remove the gear from the magnetic roller. On the gear side of the roller, pry up the flat part of the white bushing. Remove the magnetic roller. See Figure 11
12. Remove the two screws and the Dr. Blade. Be very careful not to damage the alignment pins when removing the blade. See Figure 12

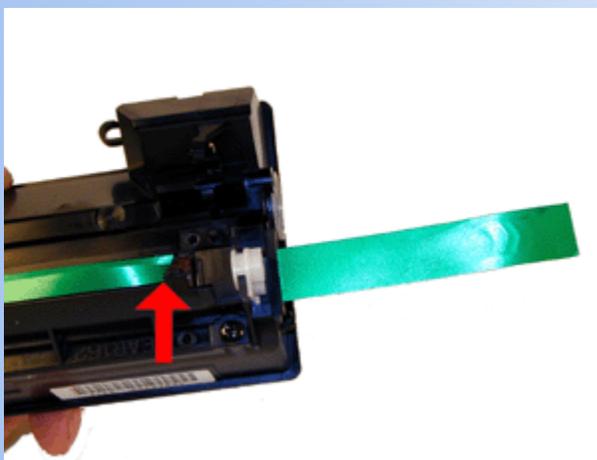
FIGURE 13

13. Clean out the entire hopper.
14. Install the seal across the framework, and slide the pull tab out the left (Non gear) side of the hopper. Make sure the tab goes under the felt seal. See Figure 13
15. Remove the fill plug, fill with 160g 585 toner, and re-install the fill plug. See Figure 14

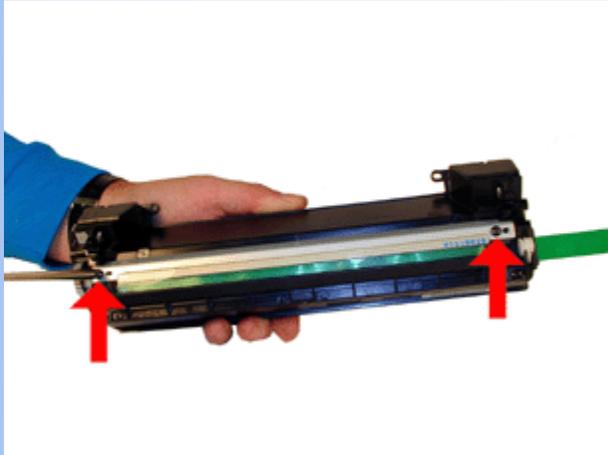
FIGURE 15

- 16. Re-install the Dr. Blade See Figure 15
- 17. Clean the metal ends of the magnetic roller, and re-install. (Don't forget the gear!) See Figure 16

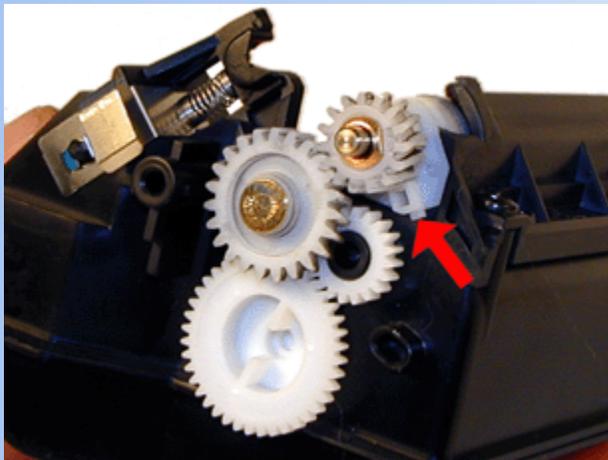
FIGURE 17

- 18. Make sure that the magnetic roller white bushing snaps back into place and that the gear meshes properly. See Figure 17
- 19. Install the cleaned PCR
- 20. Install the two hinge pins. Make sure that you don't push them in too far so that they come out easily next time. New replacement pins are not yet available. See Figure 18
