# Disassembly Instructions

## IBM 4019, 4039 and IBM 4049 Style Toner Cartridges

These instructions cover the disassembly of the IBM 4019, 4039 and 4049 style toner cartridges. The purpose of this disassembly is to vacuum out toner that will have spilled inside the cartridge during shipping and/or rough handling, to clean the debris cavity and to fill the toner supply housing with new toner. The disassembly can also be used to examine the internal parts of the cartridge for possible damage should the printing of the cartridge be poor and not correctable by other means.

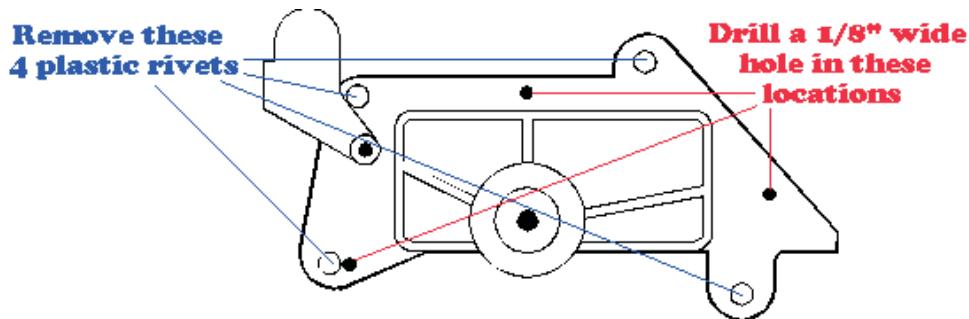
DIAGRAM 1

With the Razor blade, or Sharp chisel, slice off the heads of all four plastic rivets. With a 1/8" drill bit, drill three holes in the areas indicated in Diagram #1. By drilling the holes separate from the alignment posts, you will have a perfect alignment every time!. When the cartridge is re-assembled, you will insert the Pop Rivets which will hold the cartridge together.
