Remanufacturing the Brother HL 6050 Toner Cartridges (TN-670 in North America, TN-4100 in Europe)

0349

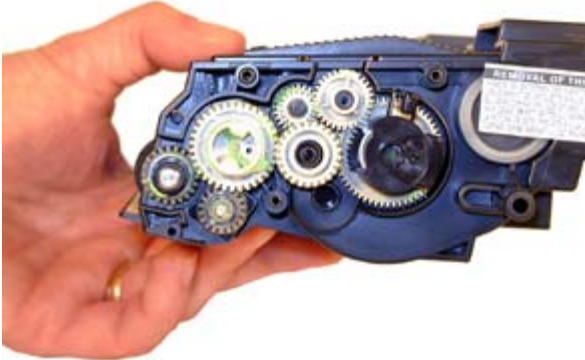
Figure 1

Figures 1 & 2 show the proper reset position of the lever. Figure 3 shows the reset lever inside the machine

These cartridges also have a gear driven reset lever that actuates another lever inside the printer. This gear driven lever must be set correctly for the printer to accept the cartridge as new. Figures 1 & 2 show the proper reset position of the lever. Figure 3 shows the reset lever inside the machine.

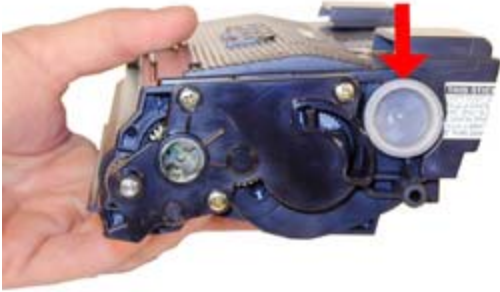
1) Remove the fill plug from the toner cartridge. Dump the remaining toner and vacuum/blow out the cartridge. Make sure that the gear area is clean. Leaving any toner in the teeth of the gears may cause a tooth to be damaged and

cause a clicking noise. We have found it best to use compressed air to clean them out, but to also keep one hand over the gears to protect them. See Figure 4

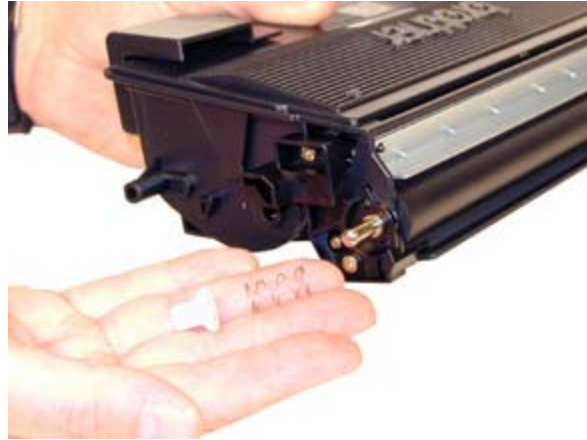
2) On the NON GEAR side of the developer roller, pry off the white spring loaded plastic axle. See Figure 5

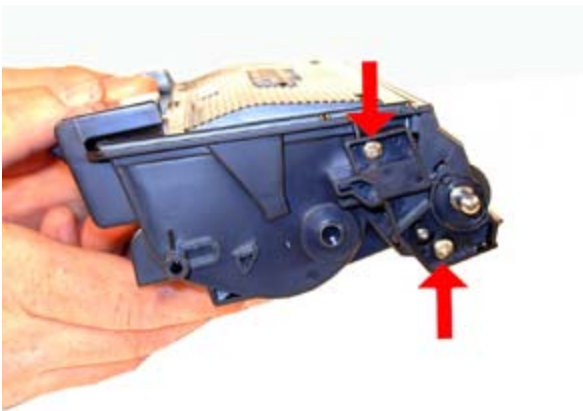
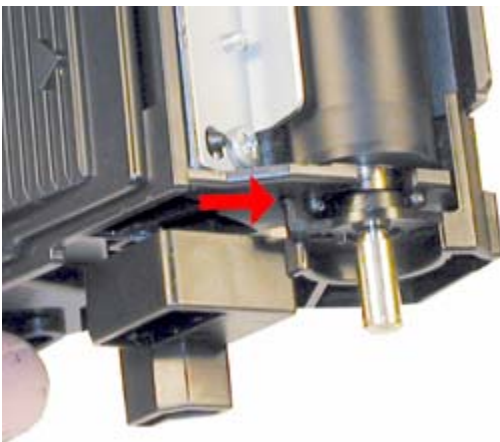
3) Remove the two screws and two tabs on the developer roller end plate and pry off. See Figures 6, 7, & 8

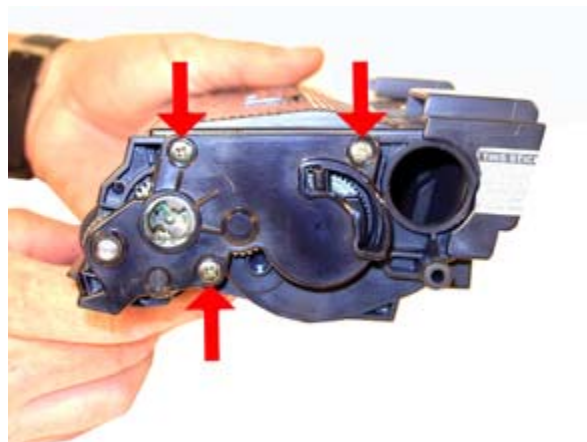
4) On the GEAR SIDE, remove the three screws and cover plate. See Figure 9

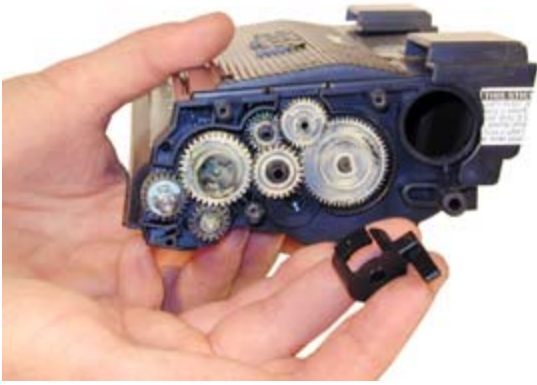
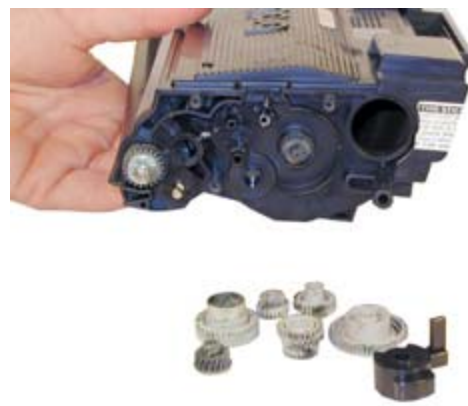
5) Remove the reset lever and gears. Make sure not to get any toner on them. See Figures 10 & 11

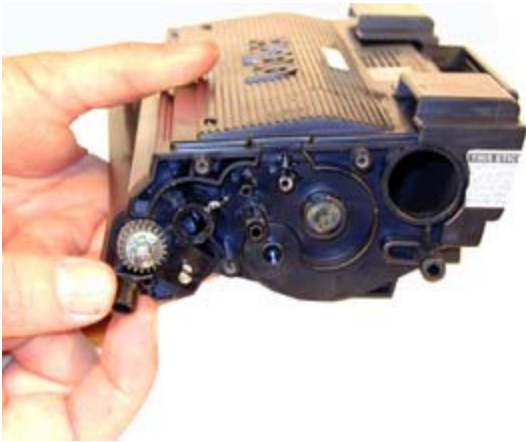
6) Remove the black axle. See Figure 12

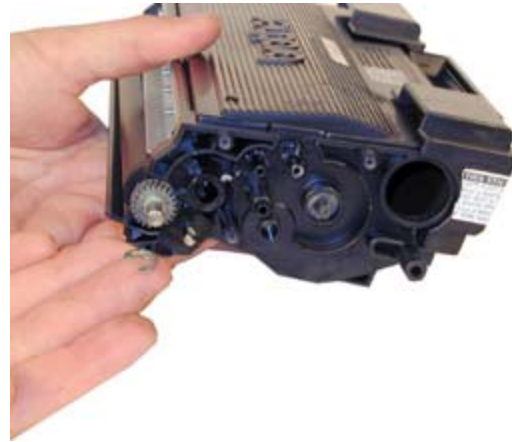
7) Remove the E-Ring, and small gear. See Figure 13

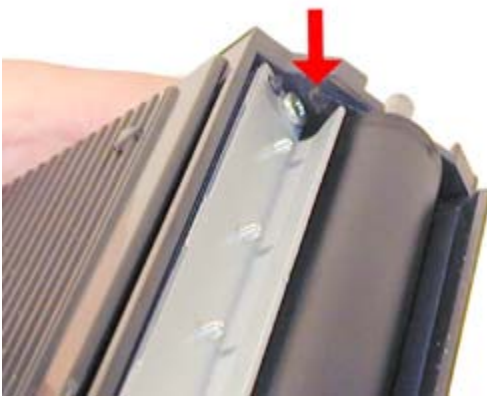
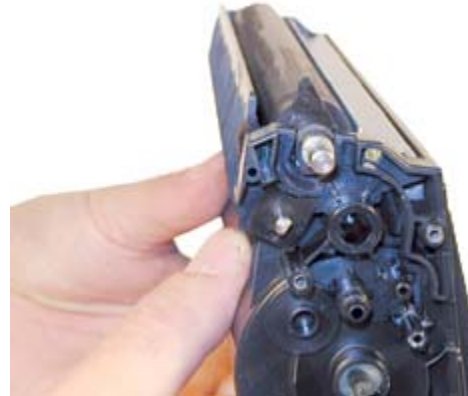
8) On the doctor blade side of the developer roller, there is another small plate that is located on the end of the roller and inside the plastic wall of the cartridge. From the outside of the wall locate a small round hole. Press in the round tab located inside the hole. While pressing in turn the plate up so that the plate and roller are free. See Figure's 14 & 15

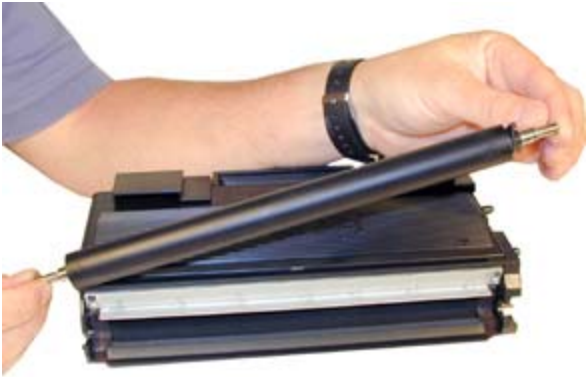
9) Remove the developer roller assembly. See Figure 16

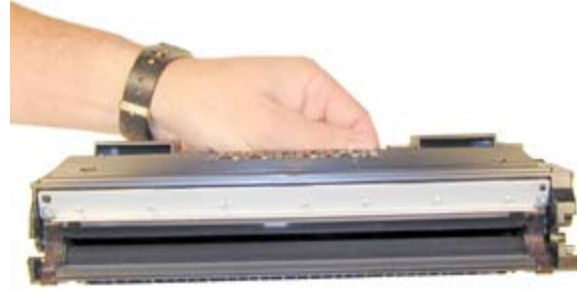
10) Vacuum the doctor blade and foam feed roller clean. We do not recommend that the doctor blade be removed or the developer roller felt seals be disturbed. Once a new blade is available, great care will have to be taken not to tear the seals, causing a leak. The doctor blade can be easily cleaned by blowing the excess toner off, and wiping down with a lint free cloth. Be very careful not to leave any lint behind! Do NOT use any chemicals on this blade. Brother toner is very touchy, and will most probably react with whatever is used. See Figure 17

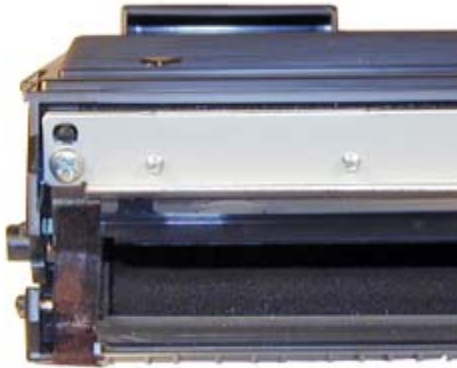
11) Inspect the magnetic roller felts. If they are compressed, (shiny) rough them up with a small screwdriver. See Figure 18

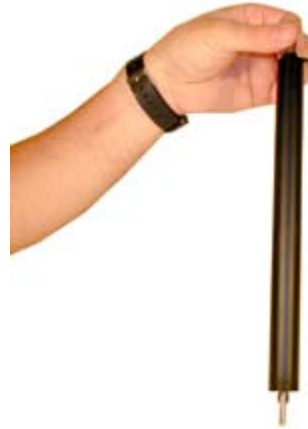
12) Clean the developer roller. If there is any type of white or blue coating on the roller, clean it off with a dedicated Brother developer roller cleaner. Do not use just any chemical to clean these rollers as it may react with either the roller sleeve, or the toner. Only a tested dedicated cleaner should be used. See Figure 19

A dirty developer roller can also cause this. If the roller has a white or bluish coating, it must be cleaned. Be sure to use only a dedicated Brother developer roller cleaner. Any other type of cleaner will probably react with the toner and cause another set of problems.

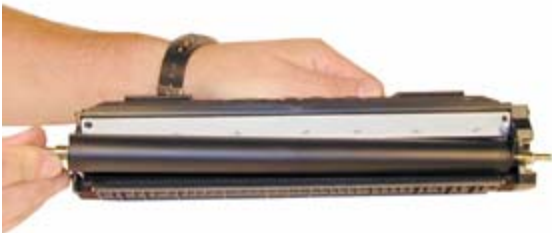
13) Re-install the developer roller, inside end plate first. Turn the inside plate so that it locks in place. See Figure 20

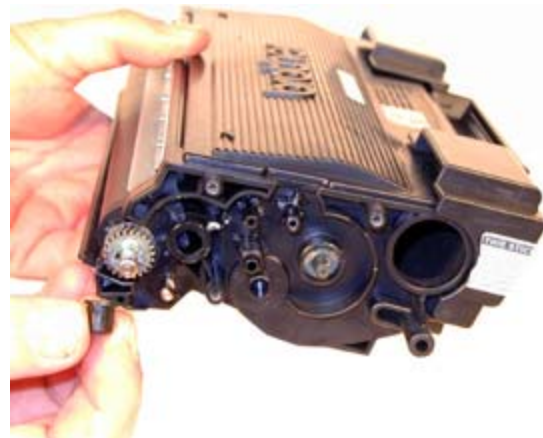
14) Install the developer roller gear, E-ring, and black axle. See Figure 21

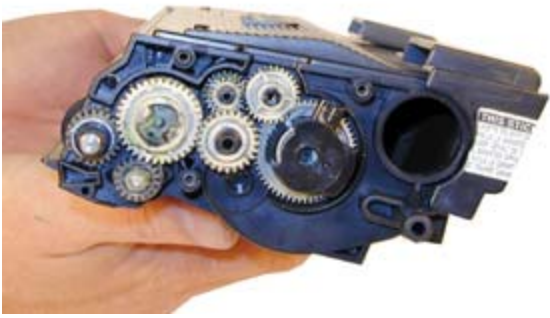
16) Install the gears and the reset lever in its proper position. Make sure all the gears are meshing properly. See Figure 22

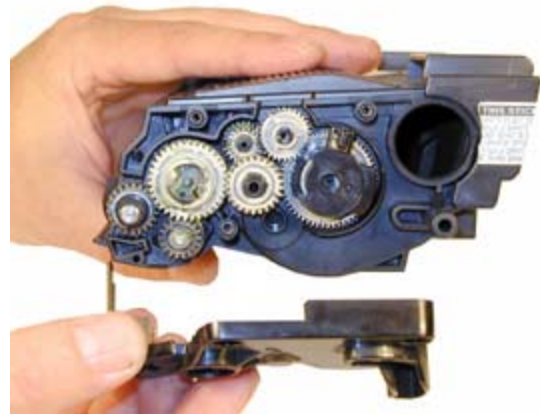
17) Install the gear cover plate, and three screws. See Figure 23

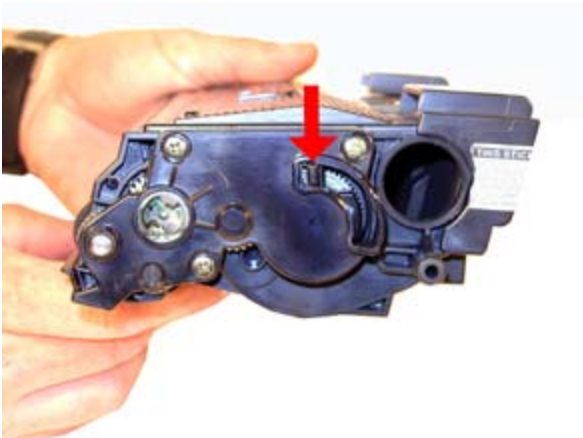
18) Make sure that the reset lever is in the proper position. See Figure 24

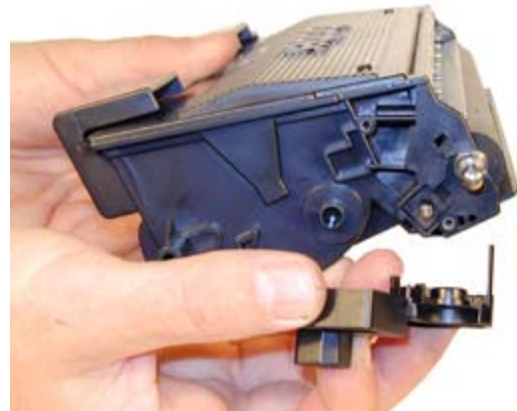
19) On the non gear side, install the developer roller end cap and two screws. Make sure that the tabs lock into place. See Figure 25

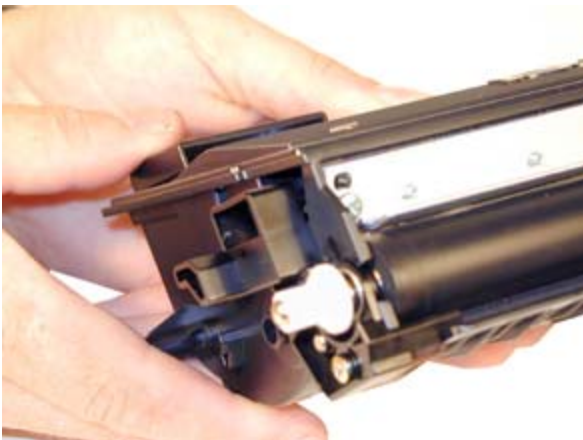
20) Install the spring-loaded white axle. See Figure 26

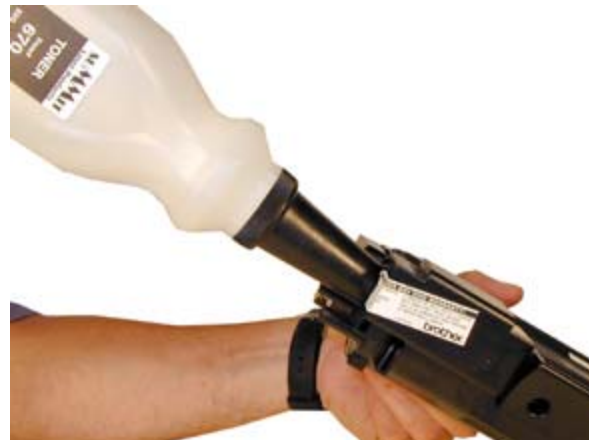
21) Fill the cartridge with Brother 6050 Black Toner. See Figure 27

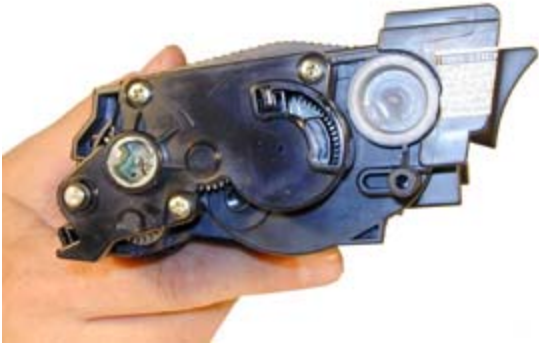
22) Replace the fill plug. See Figure 28

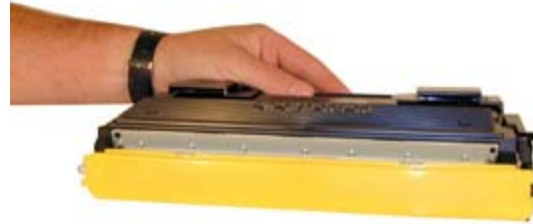
24) Install the protective developer roller cover. See Figure 29

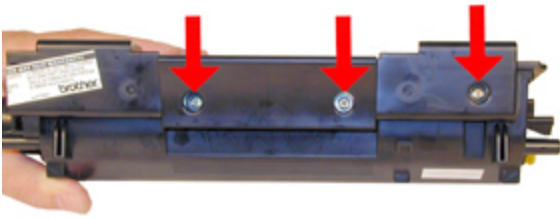
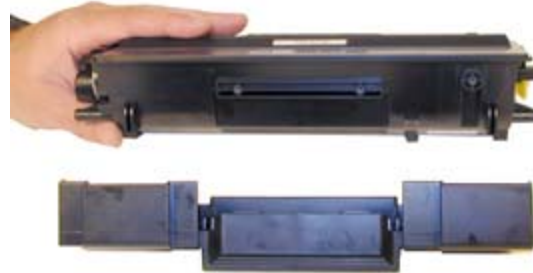
25) The back handle can be released by removing the three screws. This seems to be an easier and cheaper way to make different cartridges for other printer manufacturers. While none have been released to date (June 2004) with this modification, there is a good chance that there will be. See Figures 30 & 31
