DELL® 3000CN

TONER CARTRIDGE REMANUFACTURING INSTRUCTIONS

REMANUFACTURING THE DELL 3000CN TONER CARTRIDGE

By Javier Gonzalez and the Technical Staff at UniNet

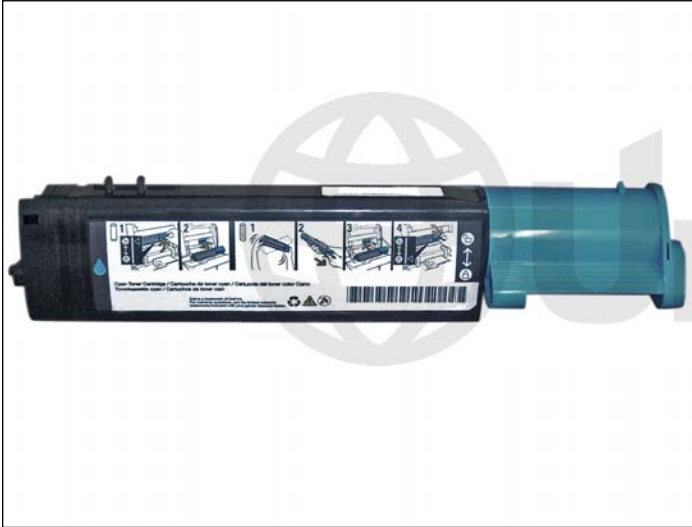
1. Disassemble the toner cartridge, starting from the lock position.

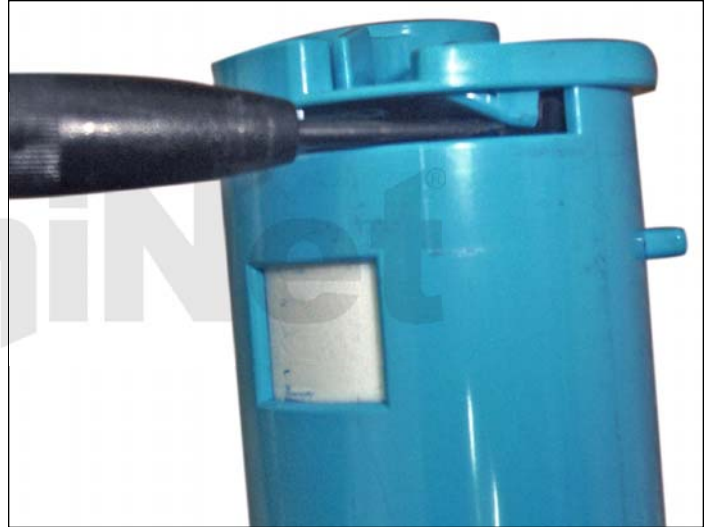
2. Use a small flat head screwdriver to lift the tab over the stopper to allow you to turn the blue end cap counter-clockwise.

NOTE: The color of the end cap will vary, depending on the color of the toner inside the cartridge.

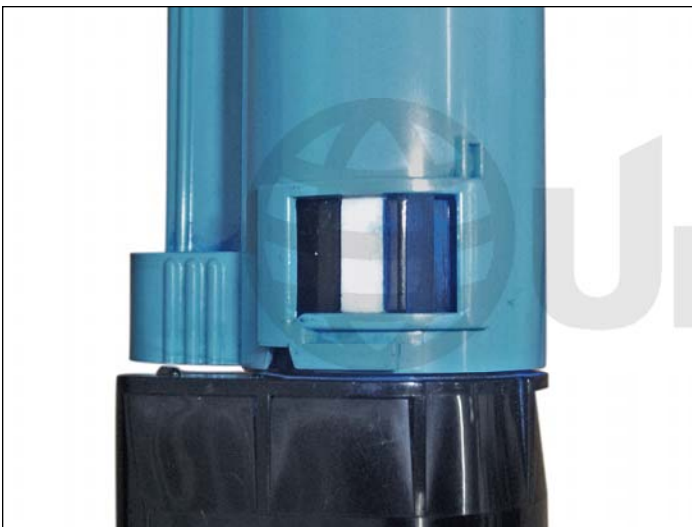
3. This is the starting point.

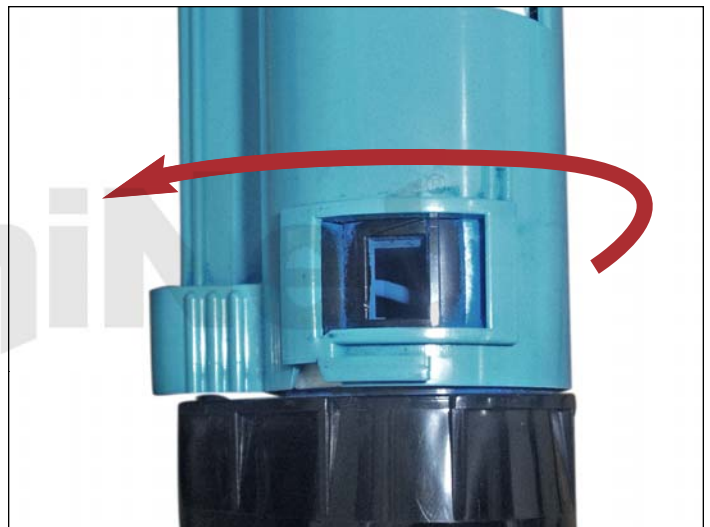
4. Turn the cap until the tab comes to a complete stop and has entered under the blue cap.

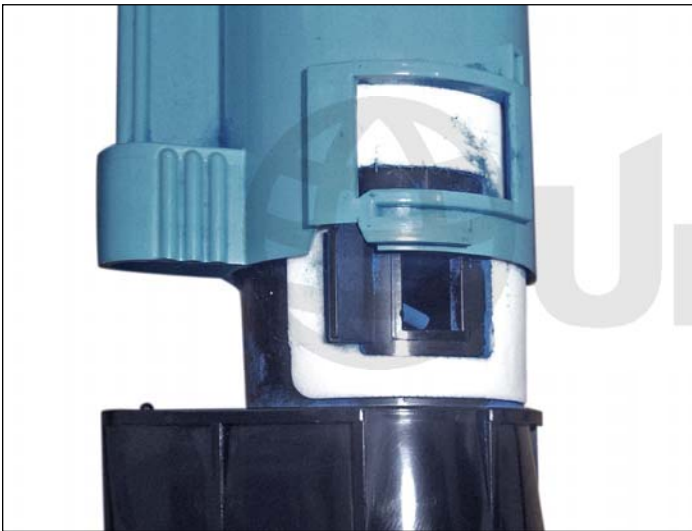
5. Now slide the cap out away from the cartridge.

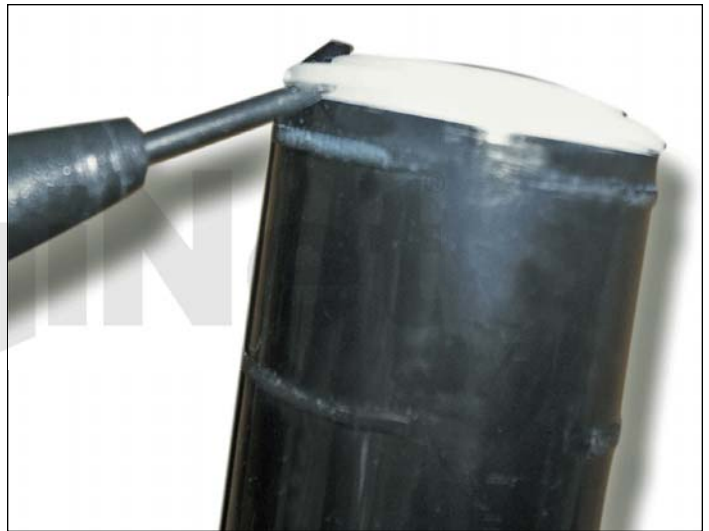
6. Remove the carrier fill plug as shown.

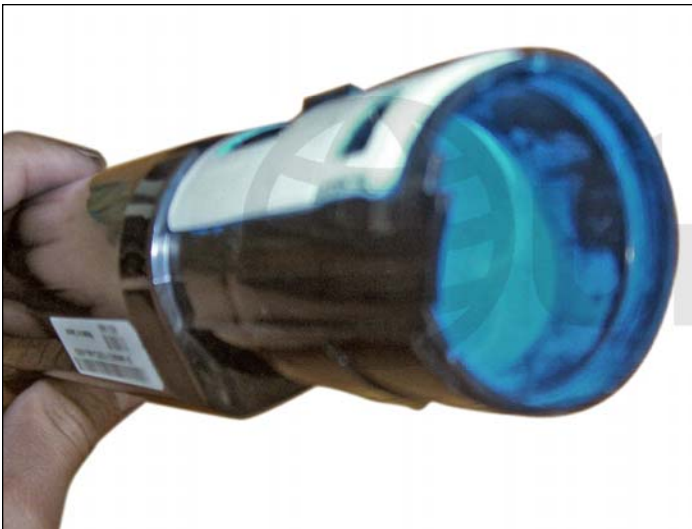
7. Shown is the waste carrier chamber. Empty it out and you will find the toner fill plug inside. Remove the plug and clean out the cartridge for refilling.

NOTE: You will need to mix toner and carrier in the same toner bottle before refilling the toner hopper.

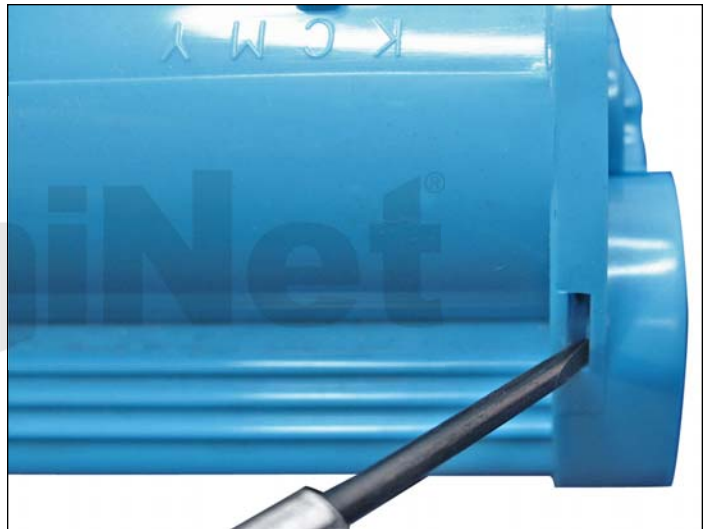
8. Using a small flat head screwdriver, unlock the chip by pressing on the release tab in the slot shown.

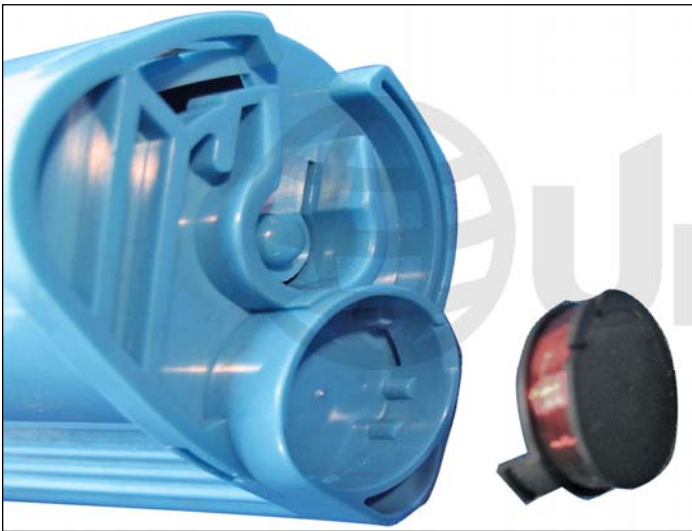
9. Make sure the replacement chip tabs enter the slots during insertion so that they lock in place.

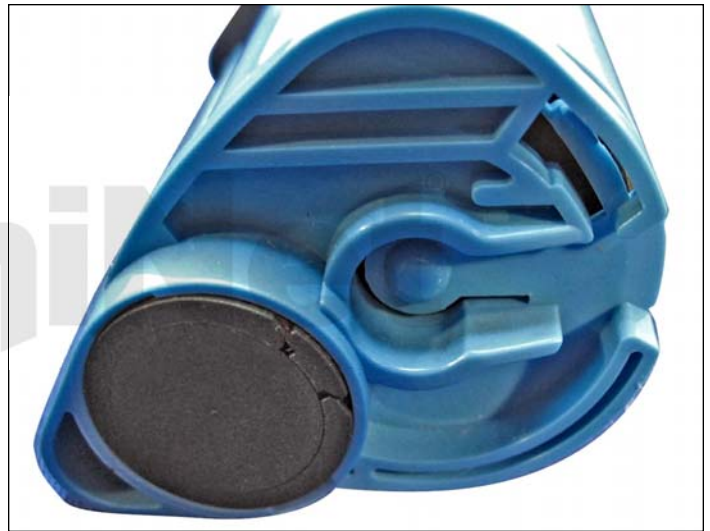
10. Replacement chip installed.
